**Flood Control Project Maintenance  
Levee Inspections**

**Fall 2014 Levee Maintenance Deficiency Summary Report**

**Flood Control Project Maintenance  
Levee Inspections**  
**LMA District Cover Sheet**  
**Fall 2014 Levee Inspection Results**

**Reclamation District No. 0544 Upper Roberts Island**

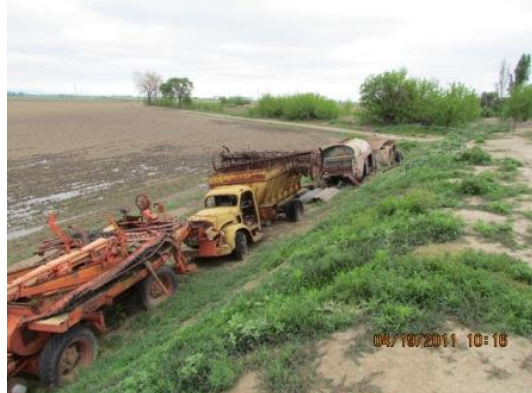
Photo 1 of 2 : FA\_2014\_RD0544\_108\_4\_20141020\_00003.jpg

LM Start	0.23	Rating **	M	Issue No.	4
LM End	0.23	Issue Type +	Ma	Location *	LS
Category	Earthen Levee			GPS Latitude/Longitude	
				Start	End
Item	Encroachments			37.867590 °	37.867590 °
				-121.327813 °	-121.327813 °
DWR ID	DWR_RD0544_01_s_2012_4				
Action/Comments					
Equipment					
Inspector Comments: Farm equipment and supplies stored at landside toe.

Looking north at equipment along landside toe.

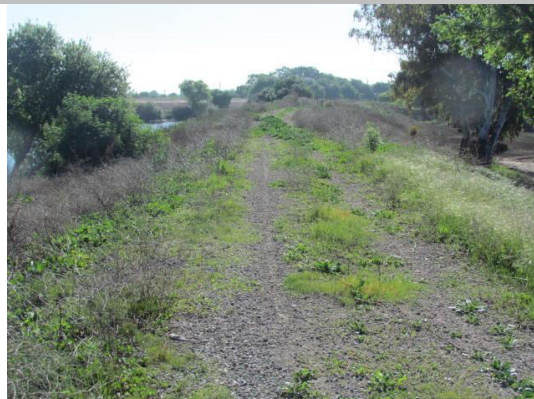
Photo 1 of 2 : FA\_2014\_RD0544\_108\_3\_20141020\_00001.jpg

Looking south at typical view of levee. (Spring 2014)

LM Start	0.48	Rating **	M	Issue No.	3
LM End	0.68	Issue Type +	Ma	Location *	WS
Category	Earthen Levee			GPS Latitude/Longitude	
				Start	End
Item	Vegetation			37.864578 °	37.863753 °
				-121.326210 °	-121.322835 °
DWR ID	DWR_RD0544_01_s_2012_3				
Action/Comments					
Remove the wild growth other than native grasses from the levee slopes.

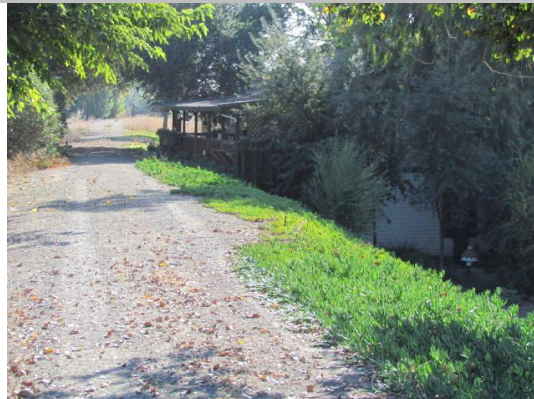
Photo 1 of 1 : FA\_2014\_RD0544\_108\_9\_20141020\_00007.jpg

LM Start	0.65	Rating **	M	Issue No.	9
LM End	0.70	Issue Type +	En	Location *	LS
Category	Earthen Levee			GPS Latitude/Longitude	
				Start	End
Item	Vegetation			37.863935 °	37.863599 °
				-121.323341 °	-121.322442 °
DWR ID	DWR_RD0544_01_s_2012_9				
Action/Comments					
Landscaping

Looking south at landscaping on landward slope.

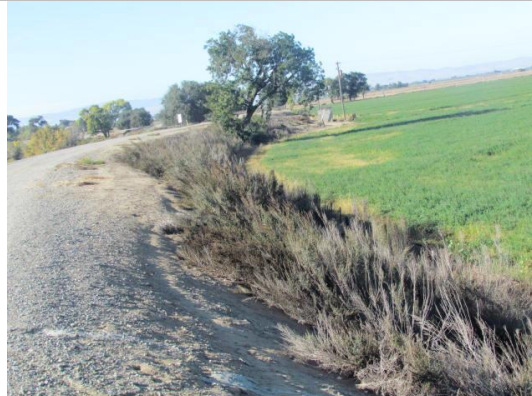
Photo 1 of 1 : FA\_2014\_RD0544\_108\_15\_20141023\_00056.jpg

Looking southeast at dense vegetation on landward toe.

LM Start	1.14	Rating **	M	Issue No.	15
LM End	1.45	Issue Type +	Ma	Location *	LS
Category	Earthen Levee			GPS Latitude/Longitude	
				Start	End
Item	Vegetation			37.859287 °	37.854252 °
				-121.318333 °	-121.324092 °
DWR ID	DWR_RD0544_01_s_2012_15				
Action/Comments					
Remove the wild growth other than native grasses from the levee slopes.

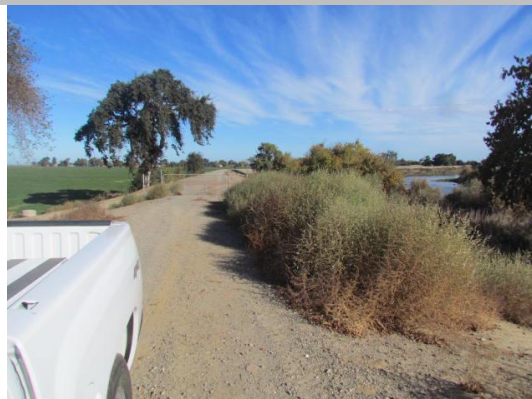
Photo 1 of 1 : FA\_2014\_RD0544\_108\_94\_20141023\_00057.jpg

Looking north at vegetation on waterward shoulder and slope.

LM Start	1.49	Rating **	M	Issue No.	94
LM End	1.52	Issue Type +	Ma	Location *	WS
Category	Earthen Levee			GPS Latitude/Longitude	
				Start	End
Item	Vegetation			37.855097 °	37.854722 °
				-121.321136 °	-121.321072 °
DWR ID	DWR_RD0544_01_f_2014_94				
Action/Comments					
Remove the wild growth other than native grasses from the levee slopes.

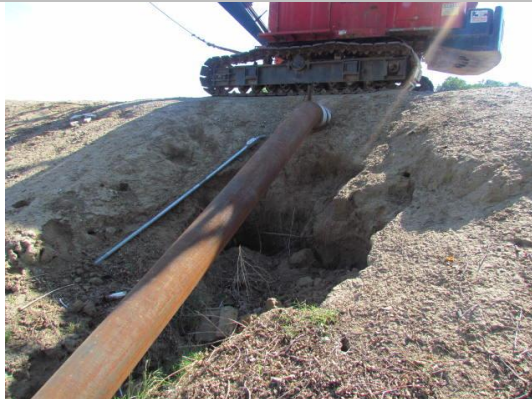
Photo 3 of 3 : FA\_2014\_RD0544\_108\_23\_20141020\_00018.jpg

LM Start	2.28	Rating **	U	Issue No.	23 (cont)
LM End	2.28	Issue Type +	Ma	Location *	LS
Category	Earthen Levee			GPS Latitude/Longitude	
				Start	End
Item	Erosion / Bank Caving			37.847985 °	37.847985 °
				-121.324837 °	-121.324837 °
DWR ID	DWR_RD0544_01_s _ 2012_23				
Action/Comments					
Schedule repair of erosion site prior to the next inspection. Inspector Comments: Caving/erosion around irrigation pipe on landside slope.

Looking east at erosion under irrigation pipe on landside slope.

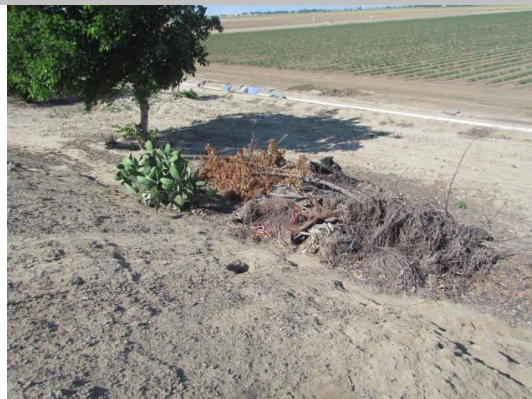
Photo 1 of 1 : FA\_2014\_RD0544\_108\_7\_20141020\_00006.jpg

LM Start	2.34	Rating **	M	Issue No.	7
LM End	2.34	Issue Type +	Ma	Location *	LS
Category	Earthen Levee			GPS Latitude/Longitude	
				Start	End
Item	Encroachments			37.847108 °	37.847108 °
				-121.324585 °	-121.324585 °
DWR ID	DWR_RD0544_01_s_2012_7				
Action/Comments					
Garbage					
Inspector Comments: Garbage and prunings at landside toe.

Looking southwest at garbage at landside toe.

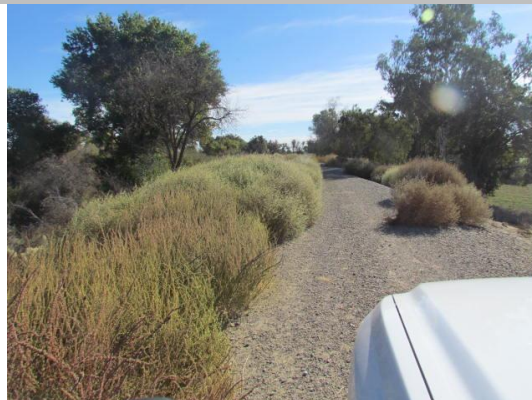
Photo 1 of 1 : FA\_2014\_RD0544\_108\_99\_20141023\_00061.jpg

Looking south at dense vegetation on waterward shoulder and slope.

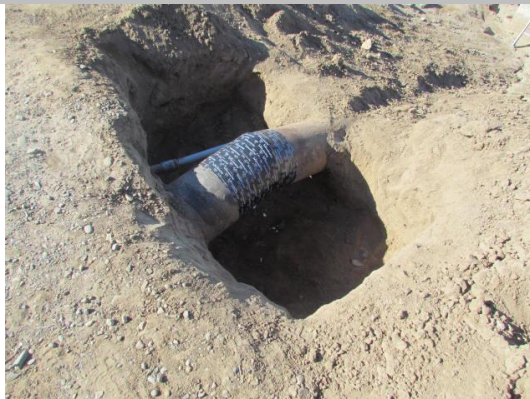
Photo 2 of 2 : FA\_2014\_RD0544\_108\_91\_20141020\_00043.jpg

Looking at open trench with irrigation pipe on landward shoulder and slope.

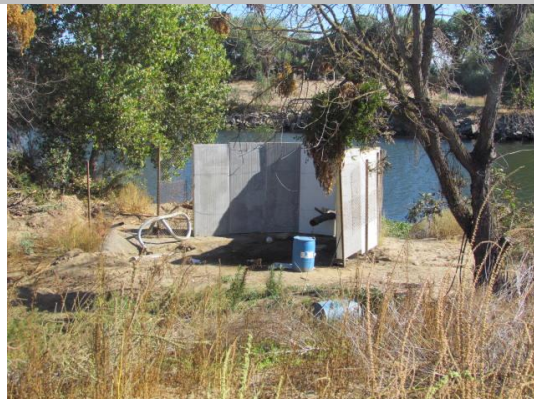
Photo 1 of 12 : FA\_2014\_RD0544\_108\_16\_20141023\_00066.jpg

Looking east at concrete wall on waterward berm.

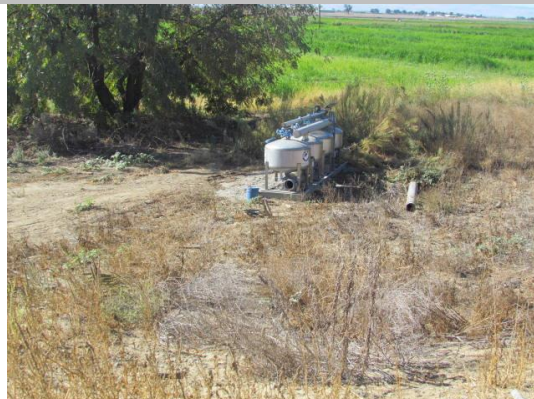
Photo 2 of 12 : FA\_2014\_RD0544\_108\_16\_20141023\_00067.jpg

Looking west at filter system on landward berm

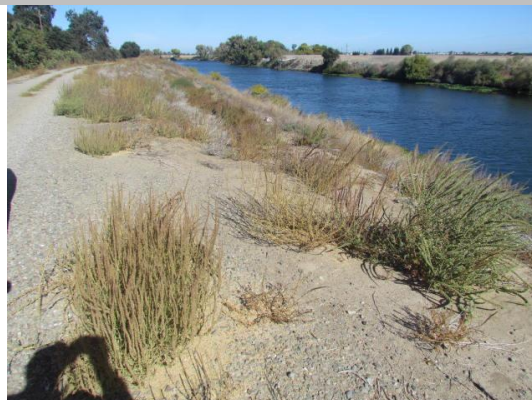
Photo 1 of 1 : FA\_2014\_RD0544\_108\_37\_20141023\_00070.jpg

LM Start	3.31	Rating **	M	Issue No.	37
LM End	3.31	Issue Type +	En	Location *	WS
Category	Earthen Levee			GPS Latitude/Longitude	
				Start	End
Item	Encroachments			37.835951 °	37.835951 °
				-121.317062 °	-121.317062 °
DWR ID	DWR_RD0544_01_s_2012_37				
Action/Comments					
Ramp					
Inspector Comments: Landowner has cut new ramp on waterside slope.

Looking north at ramp on waterward slope.

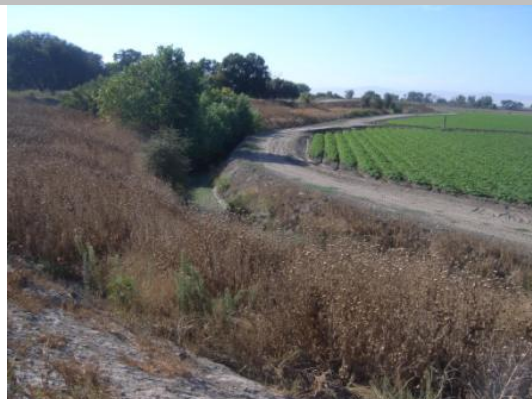
Photo 1 of 1 : FA\_2014\_RD0544\_108\_163\_20141020\_00044.jpg

LM Start	4.96	Rating **	U	Issue No.	163
LM End	5.05	Issue Type +	En	Location *	LS
Category	Earthen Levee			GPS Latitude/Longitude	
				Start	End
Item	Encroachments				37.818125 °
					-121.319070 °
DWR ID	DWR_RD0544_01_s_2012_163				
Action/Comments					
Ditch					
Inspector Comments: Agricultural ditch on landside toe.

Looking southwest at ditch on landside slope and toe.

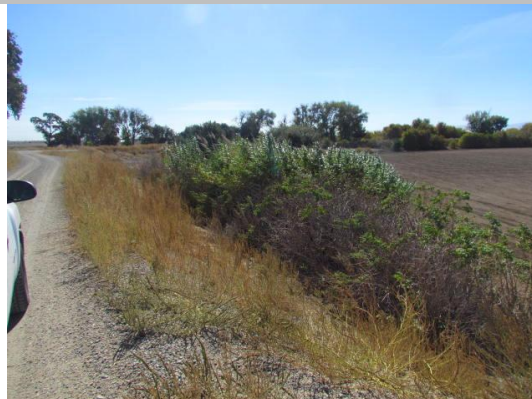
Photo 1 of 1 : FA\_2014\_RD0544\_108\_35\_20141023\_00075.jpg

LM Start	5.39	Rating **	U	Issue No.	35
LM End	5.39	Issue Type +	Ma	Location *	LS
Category	Earthen Levee			GPS Latitude/Longitude	
				Start	End
Item	Vegetation			37.813659 °	37.813659 °
				-121.319614 °	-121.319614 °
DWR ID	DWR_RD0544_01_s_2012_35				
Action/Comments					
Trees / Woody Vegetation					
Inspector Comments: Bamboo blocking landward toe.

Looking south at bamboo on landward slope and toe.

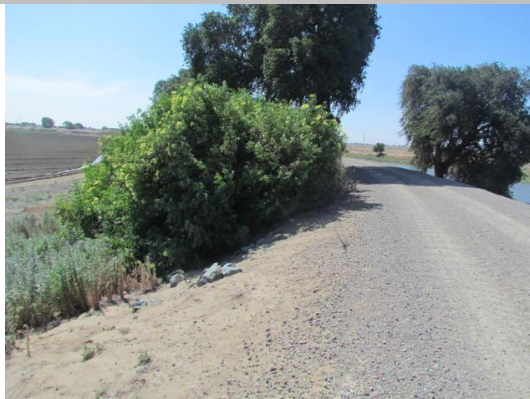
Photo 2 of 3 : FA\_2014\_RD0544\_109\_4\_20141020\_00002.jpg

LM Start	0.41	Rating **	U	Issue No.	4 (cont)	
LM End	0.41	Issue Type +	Ma	Location *	LS	
Category	Earthen Levee			GPS Latitude/Longitude		
				Start		End
Item	Vegetation			37.809788 °		37.809788 °
				-121.334727 °		-121.334727 °
DWR ID	DWR_RD0544_02_s_2012_4					
Action/Comments						
Elderberries are blocking visibility and flood fight capability.

Looking northwest at elderberry on landside slope. (Spring 2012)

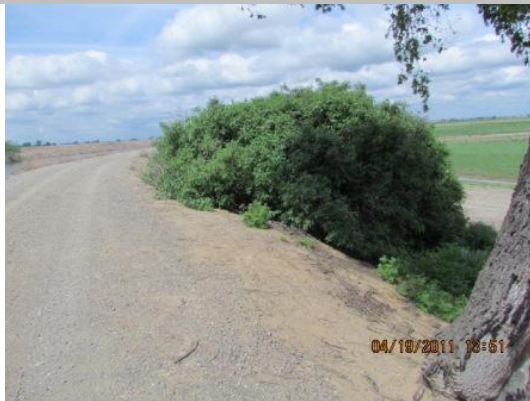
Photo 3 of 3 : FA\_2014\_RD0544\_109\_4\_20141020\_00003.jpg

Looking south at elderberries on landside slope.

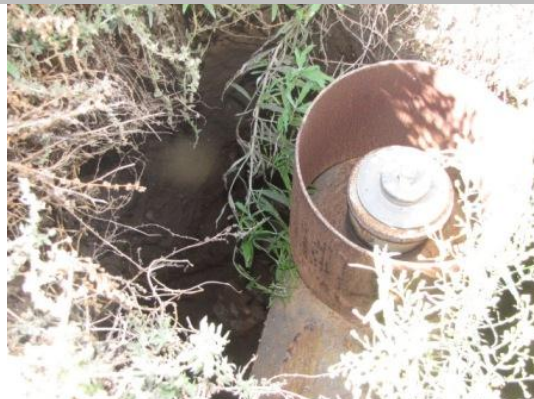
Photo 2 of 8 : FA\_2014\_RD0544\_109\_8\_20141020\_00007.jpg

Looking at caving around 10" siphon pipe on waterside shoulder.

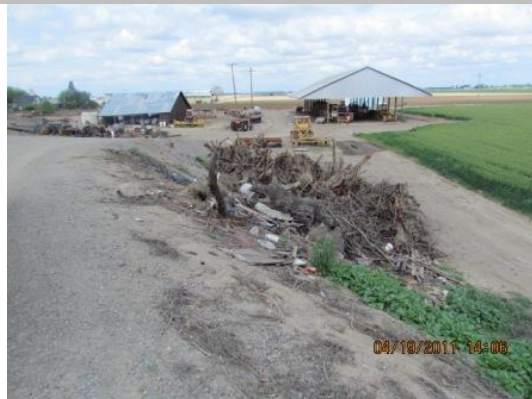
Photo 2 of 4 : FA\_2014\_RD0544\_109\_20\_20141020\_00024.jpg

Looking southwest at pruning pile on landside slope.

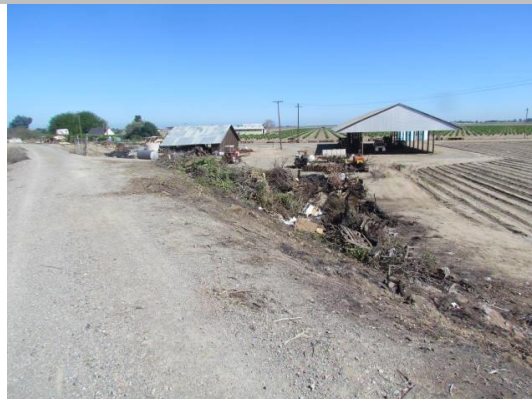
Photo 3 of 4 : FA\_2014\_RD0544\_109\_20\_20141020\_00025.jpg

LM Start	1.14	Rating **	U	Issue No.	20 (cont)
LM End	1.14	Issue Type +	En	Location *	LS
Category	Earthen Levee			GPS Latitude/Longitude	
				Start	End
Item	Encroachments			37.819530 °	37.819530 °
				-121.333827 °	-121.333827 °
DWR ID	DWR_RD0544_02_s_2012_20				
Action/Comments					
Prunings					
Inspector Comments: Rubber tires and other items have been added to pruning pile.

Looking southwest at pruning &amp; garbage piles at landward toe. (Spring 2014)

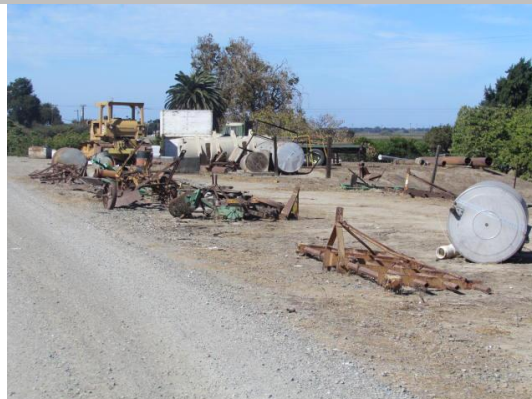
Photo 1 of 3 : FA\_2014\_RD0544\_109\_18\_20141023\_00049.jpg

LM Start	1.17	Rating **	M	Issue No.	18
LM End	1.23	Issue Type +	En	Location *	LS
Category	Earthen Levee			GPS Latitude/Longitude	
				Start	End
Item	Encroachments			37.819830 °	37.820235 °
				-121.334233 °	-121.335268 °
DWR ID	DWR_RD0544_02_s_2012_18				
Action/Comments					
Abandoned vehicles Inspector Comments: Vehicles and farm equipment stored on landside for several years. Area is defined a oversize levee. Landowner is in the process of moving items from landward shoulder.

Looking southwest at equipment stored on landward shoulder.

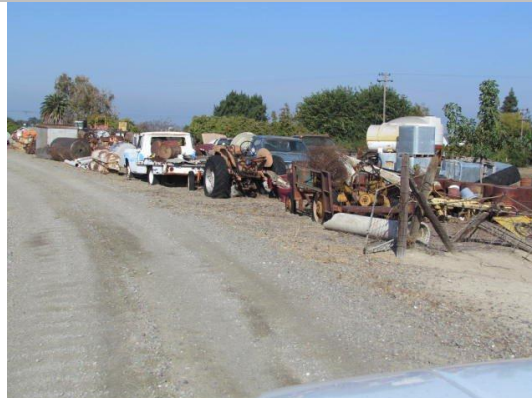
Photo 3 of 3 : FA\_2014\_RD0544\_109\_18\_20141020\_00022.jpg

Looking southwest at farm equipment, vehicles, and other items stored on landside landing.

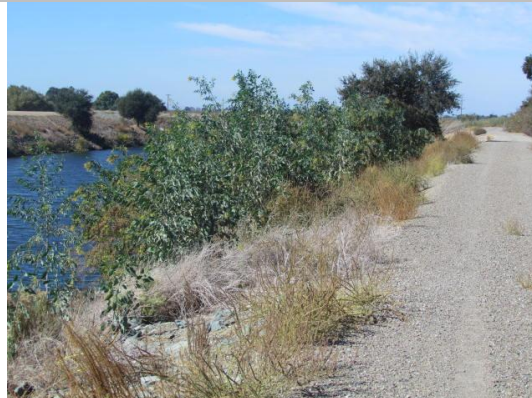
Photo 1 of 1 : FA\_2014\_RD0544\_109\_49\_20141023\_00050.jpg

LM Start	1.27	Rating **	M	Issue No.	49
LM End	1.32	Issue Type +	Ma	Location *	WS
Category	Earthen Levee			GPS Latitude/Longitude	
				Start	End
Item	Vegetation			37.820486 °	37.820767 °
				-121.336062 °	-121.336611 °
DWR ID	DWR_RD0544_02_f_2014_49				
Action/Comments					
Remove the wild growth other than native grasses from the levee slopes.					
Inspector Comments: Tobacco plants on waterward slope.

Looking south at several tobacco plants on waterward slope.

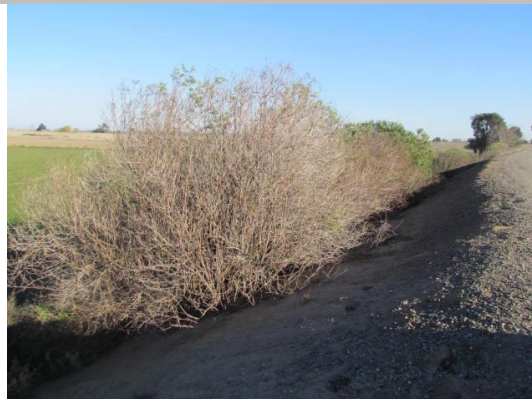
Photo 1 of 1 : FA\_2014\_RD0544\_109\_13\_20141020\_00018.jpg

LM Start	2.11	Rating **	M	Issue No.	13
LM End	2.12	Issue Type +	Ma	Location *	LS
Category	Earthen Levee			GPS Latitude/Longitude	
				Start	End
Item	Vegetation			37.819337 °	37.819460 °
				-121.344275 °	-121.344492 °
DWR ID	DWR_RD0544_02_s_2012_13				
Action/Comments					
Elderberries are blocking visibility and flood fight capability.

Looking northwest at elderberries on landside slope and toe.

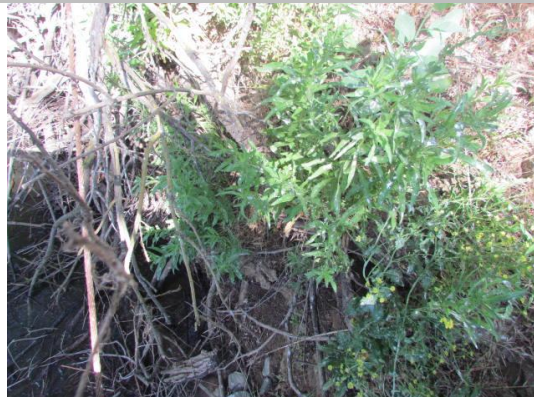
Photo 1 of 3 : FA\_2014\_RD0544\_109\_24\_20141020\_00032.jpg

LM Start	2.35	Rating **	U	Issue No.	24
LM End	2.35	Issue Type +	Ma	Location *	WS
Category	Rivers, Channels & Designated Floodways			GPS Latitude/Longitude	
				Start	End
Item	Erosion / Bank Caving			37.821763 °	37.821763 °
				-121.347275 °	-121.347275 °
DWR ID	DWR_RD0544_02_s_2012_24				
Action/Comments					
Inspector Comments: Large erosion and beaver activity at waterside toe of levee.

Looking south at beaver hole at waterside toe.

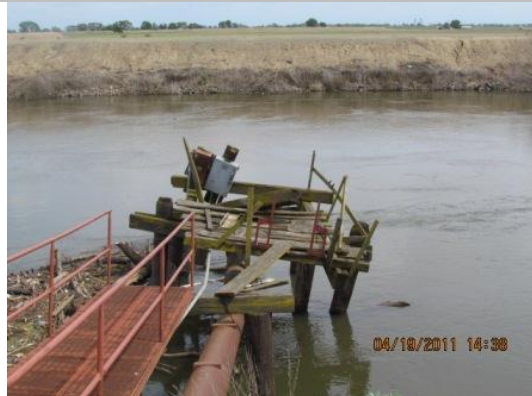
Photo 1 of 1 : FA\_2014\_RD0544\_109\_17\_20141020\_00020.jpg

Looking east at dilapidated pump platform.

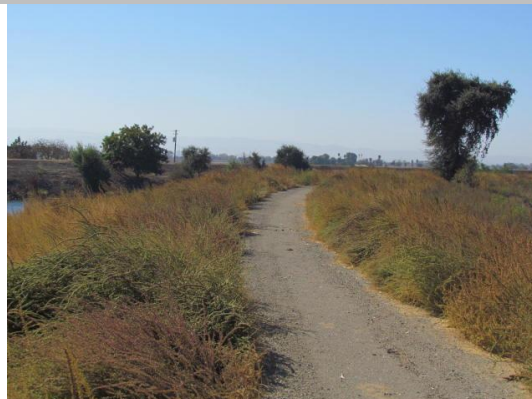
Photo 1 of 1 : FA\_2014\_RD0544\_109\_43\_20141020\_00037.jpg

Looking south a dense vegetation on landward and waterward slope.

LM Start	2.76	Rating **	U	Issue No.	43
LM End	3.23	Issue Type +	Ma	Location *	LS
Category	Earthen Levee			GPS Latitude/Longitude	
				Start	End
Item	Vegetation			37.817747 °	37.817497 °
				-121.351578 °	-121.357490 °
DWR ID	DWR_RD0544_02_s_2012_43				
Action/Comments					
Remove the wild growth other than native grasses from the levee slopes.

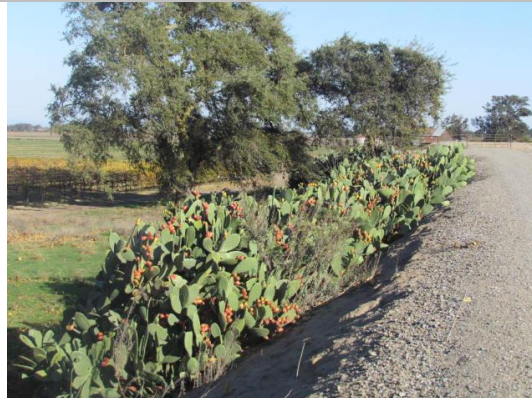
Photo 1 of 2 : FA\_2014\_RD0544\_109\_36\_20141020\_00035.jpg

LM Start	3.53	Rating **	M	Issue No.	36
LM End	3.56	Issue Type +	Ma	Location *	LS
Category	Earthen Levee			GPS Latitude/Longitude	
				Start	End
Item	Vegetation			37.819576 °	37.819530 °
				-121.364056 °	-121.364653 °
DWR ID	DWR_RD0544_02_s_2012_36				
Action/Comments					
Remove the wild growth other than native grasses from the levee slopes.					
Inspector Comments: Cactus on landside slope.

Looking north at cactus on landside slope and toe.
